Manhole Inspection Summary

Manhole # S17CC1021MH

Inspection ☐ Is Incomplete Rating: **4) Poor**

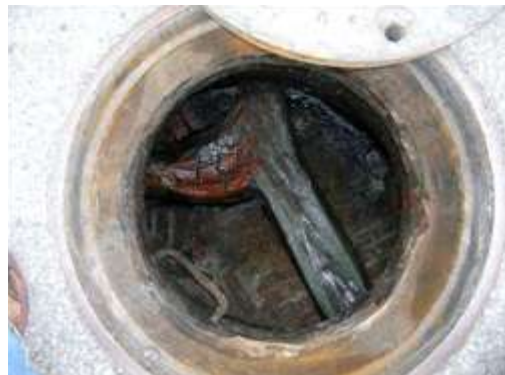
Top View

Evidence of surcharge - Bench debris.
Corroded steps.

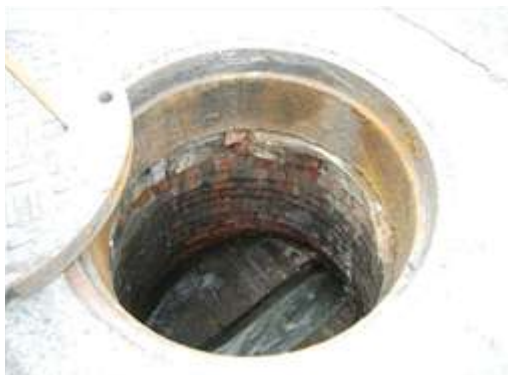
Defect

Frame leaks. Adjustment deterioration,
loose brick and infiltration. Corbel and
Barrel infiltration.

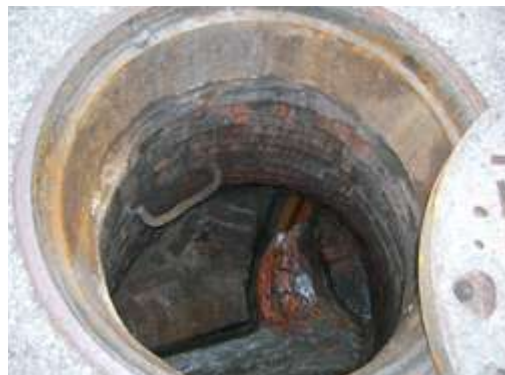
Defect

Frame leaks. Adjustment, Corbel and
Barrel infiltration.

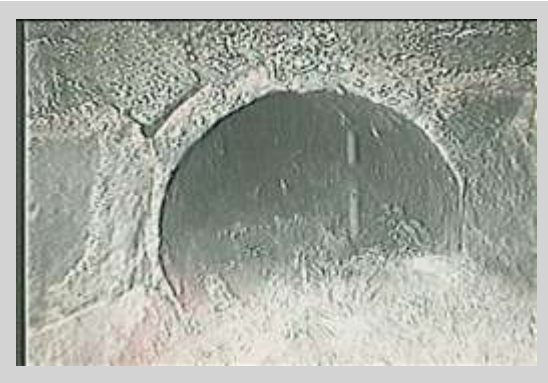
8 in. Circular Gravity Sewer Pipe Out @ 12 O'Clock

Channel deterioration.

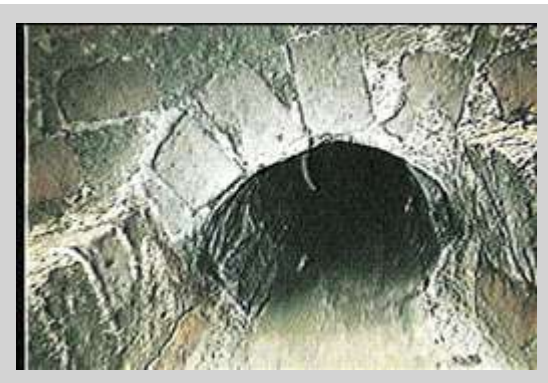
8 in. Circular Gravity Sewer Pipe In @ 5 O'Clock

Channel deterioration.

Infiltration: **Evidence** Pipe Seal Cond: **Unknown**

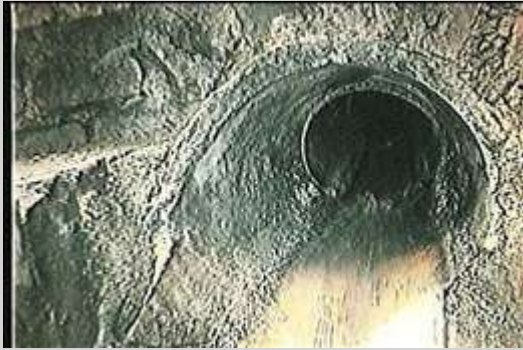
Pipe In @ 10 O'Clock

Barrel deterioration and infiltration.

Infiltration: **Evidence**
